**RARE AND UNUSUAL WW1 GERMAN FINAL 1918 PATTERN AIRCRAFT
BALKAN CROSS CIRCA PROBABLY FROM A RUMPLER CIV, SHOWING
AT LEAST ONE TRANSITIONAL OVER PAINT OVER THE ORIGINAL
CROSS PATTEE**

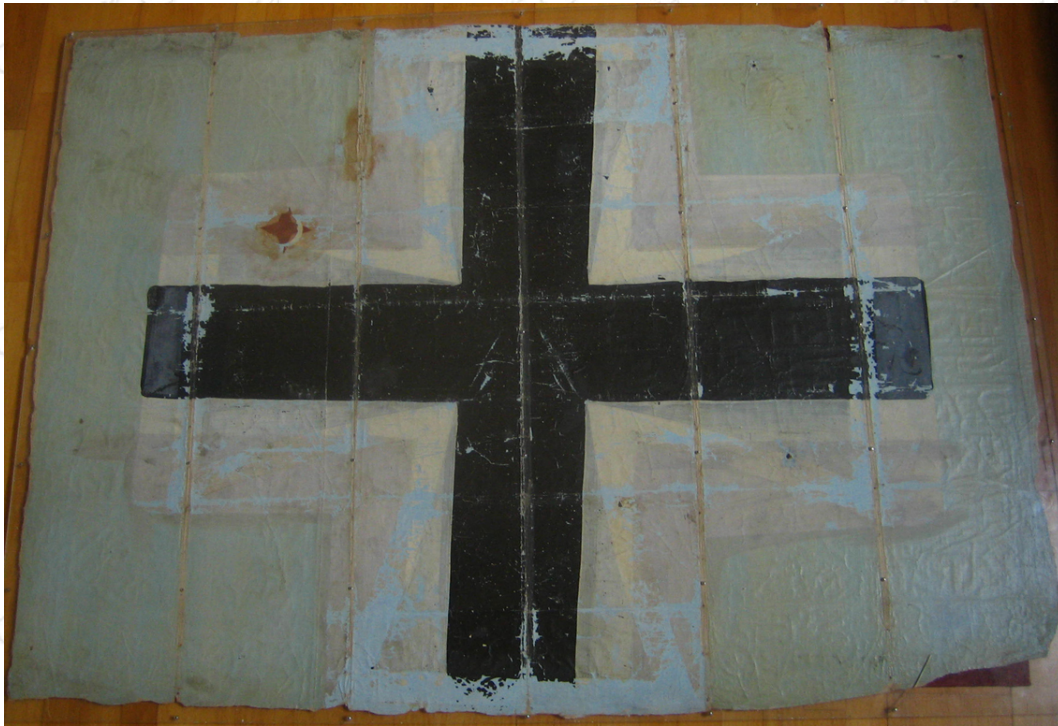
A large piece of fabric with Balkan Cross (Balkenkreuz) to the centre, measuring 180cm x 127cm from the underside of lower wings of a WW1 German aircraft. From size, location of wing ribs, strut location holes and where the fabric curves towards the tip, it's a near perfect match for a Rumpler CIV. This was a very common two seater in service from early 1917 right up to the end of the War.

Of particular note and interest is the fact that the late war pattern Balkan Cross with the thinner white border has been painted over the earlier Cross Pattee, which is still faintly visible. More unusual still is it may even have been repainted over the first pattern of Balkan Cross which had a wider white border. If this is the case, we have;

Also of note is the background colour. Where the area of paint have come away the original brighter sky blue colour can be seen. At some point in the aircrafts life this colour was either over painted with a slightly less bright blue of given a wash of a slightly darker paint to dull it down a little.

Condition is very good. There is some flaking to paint, especially to areas of the white paint. This is often seen on fabric crosses as the white paint that was used doesn't seem to adhere as well. However on this particular piece of fabric, the flaking has actually served make the outline of the Cross Pattee more visible. Also of note a various small period parch where the

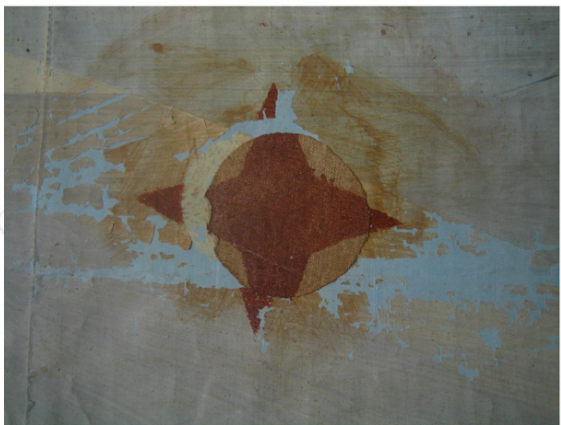
BULLET HOLE PATCH FROM FRONT OF FABRIC

fabric has been pierced by a bullet or shrapnel. A couple of other holes are where bracing wires or such were attached.

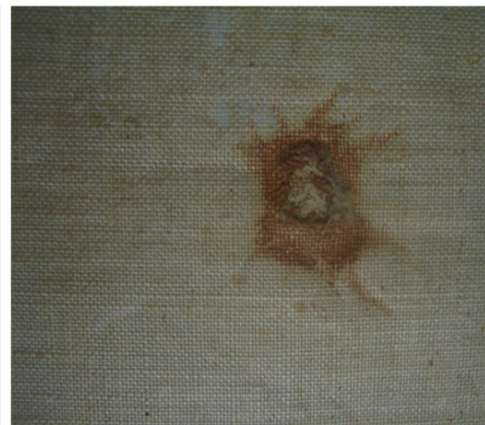
BULLET HOLE FROM REAR OF FABRIC

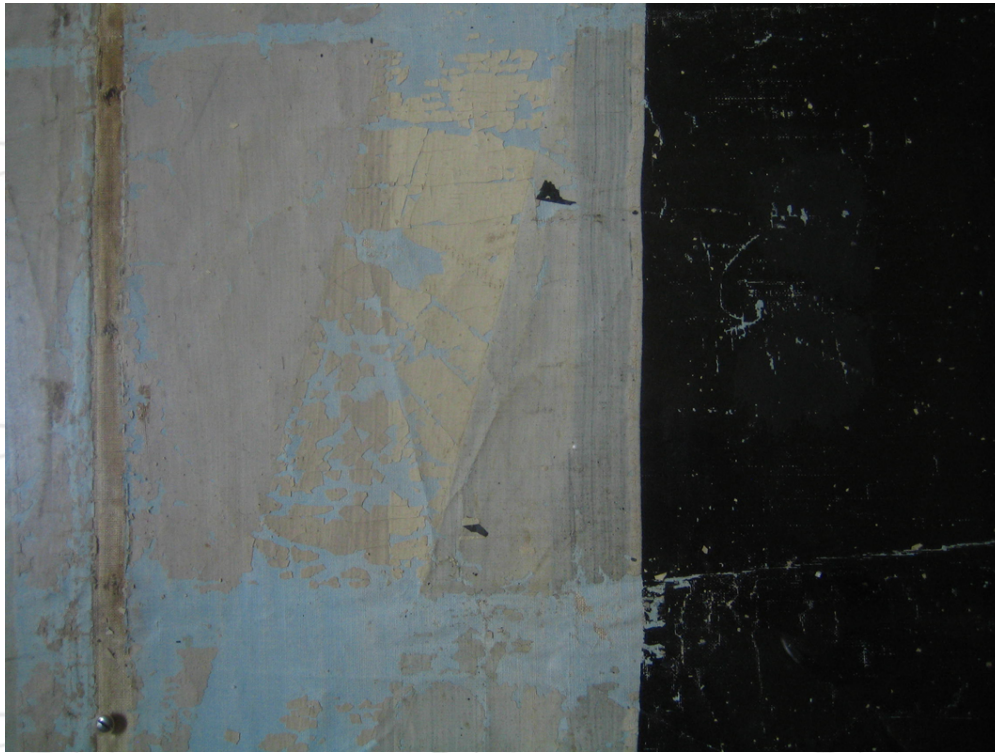
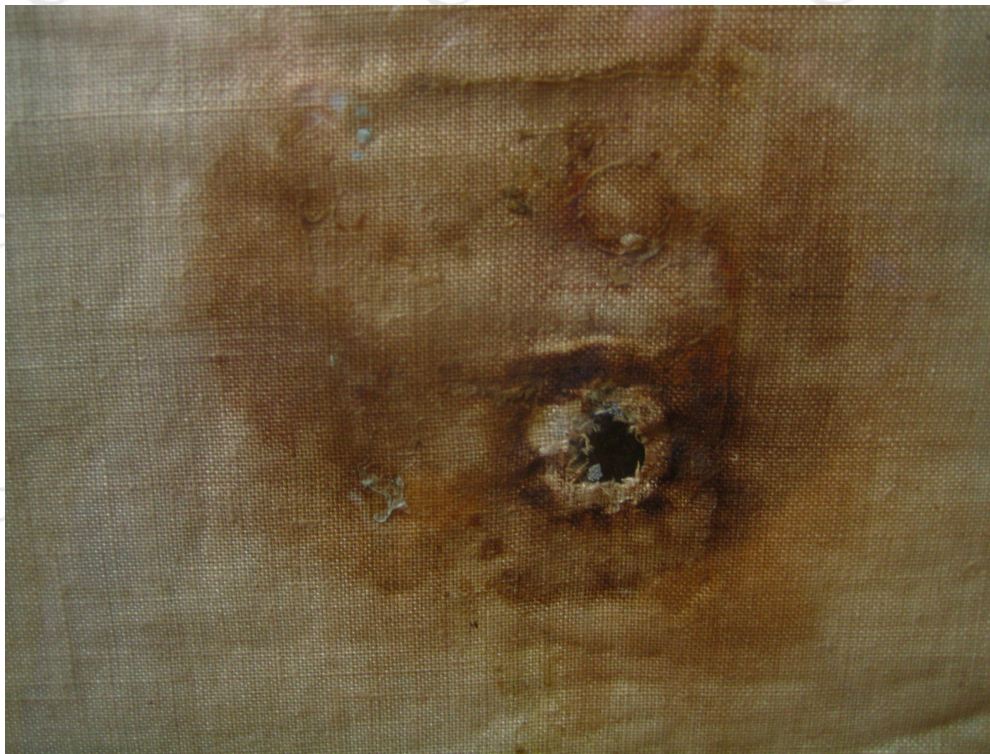
Below are plans of the lower wing of a Rumpler CIV with the fabric cross superimposed over it to show just how close a match there is. The plans themselves are scaled up from 1/48, so there is a little leeway of perhaps a cm or two here and there. However key points are the

width of the fabric is 127cm, the chord on a Rumpler is 133cm, so a perfect fit allowing for a couple of cm to be lost either side of the fabric when it was cut from the frame.
