SECTIONS OF WW1 GERMAN AIRCRAFT CROSS FABRIC FROM THE LOWER WING CIRCA 1916

Sections of clear doped fabric from the lower wing of a WW1 German aircraft.

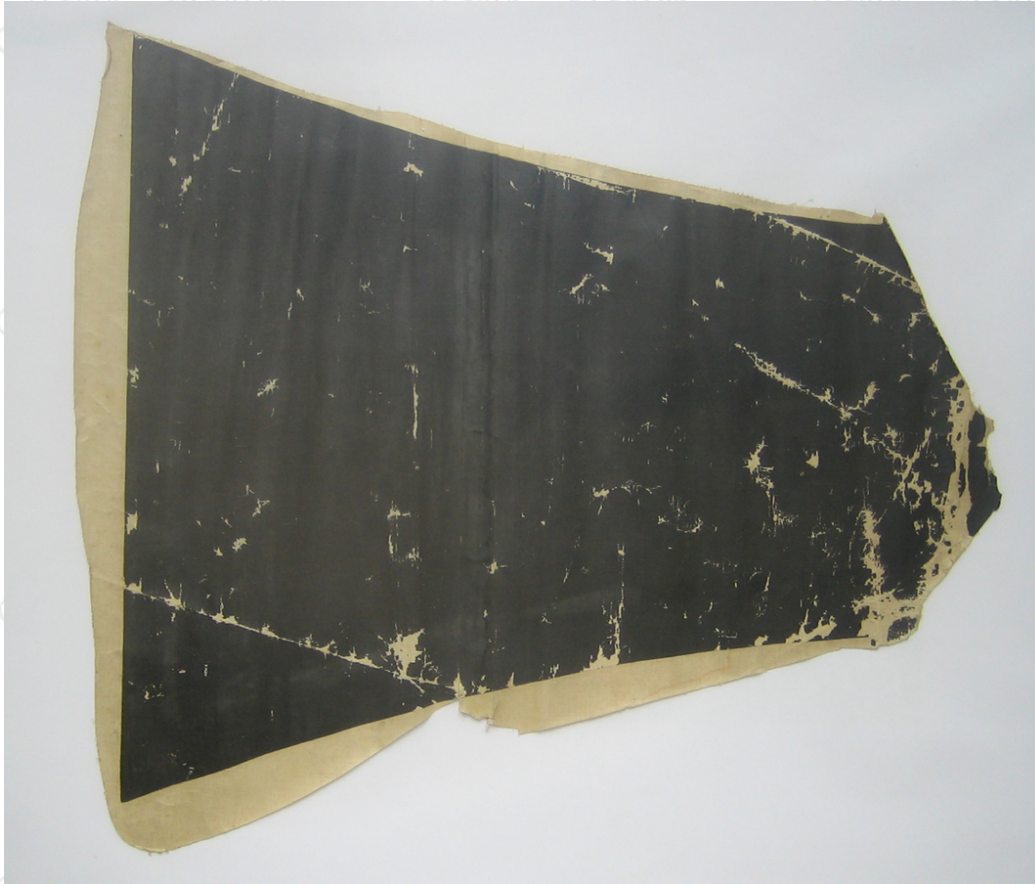
The fabric measures 61cm vertically and 67cm horizontally. The fabric features the left or right horizontal arm of a cross. We can see it's the horizontal portion due to where the rib tape goes through the cross. The cross itself measures 63cm horizontally and the length at the vertical is 56.5cm and a rough calculation of its original size would give a cross of 138cm had all the arms been present. The reverse of the fabric shows evidence of where the rib was stitched to the wing rib. We can see it's a lower wing cross as it has no white border and its size, fabric type, condition etc suggests a match for the larger section also offered for sale.

The condition of the fabric is very good but with a little more flaking to the paint than the upper wing cross. This also has a more matt finish. The fabric is still relatively supple.

The cross sizes would fit a standard two seater of the period, such as an Albatros CV but there are numerous types it could be. Condition etc suggests a match for the smaller section also offered for sale.
